GULFCO MARINE MAINTENANCE FREEPORT, BRAZORIA COUNTY, TEXAS

Figure 6A DETECTED CONCENTRATIONS EXCEEDING ECOLOGICAL SCREENING LEVELS FOR SOIL INVERTEBRATES* - SOUTH AREA SOIL

PASTOR, BEHLING & WHEELER, LLC
CONSULTING ENGINEERS AND SCIENTISTS

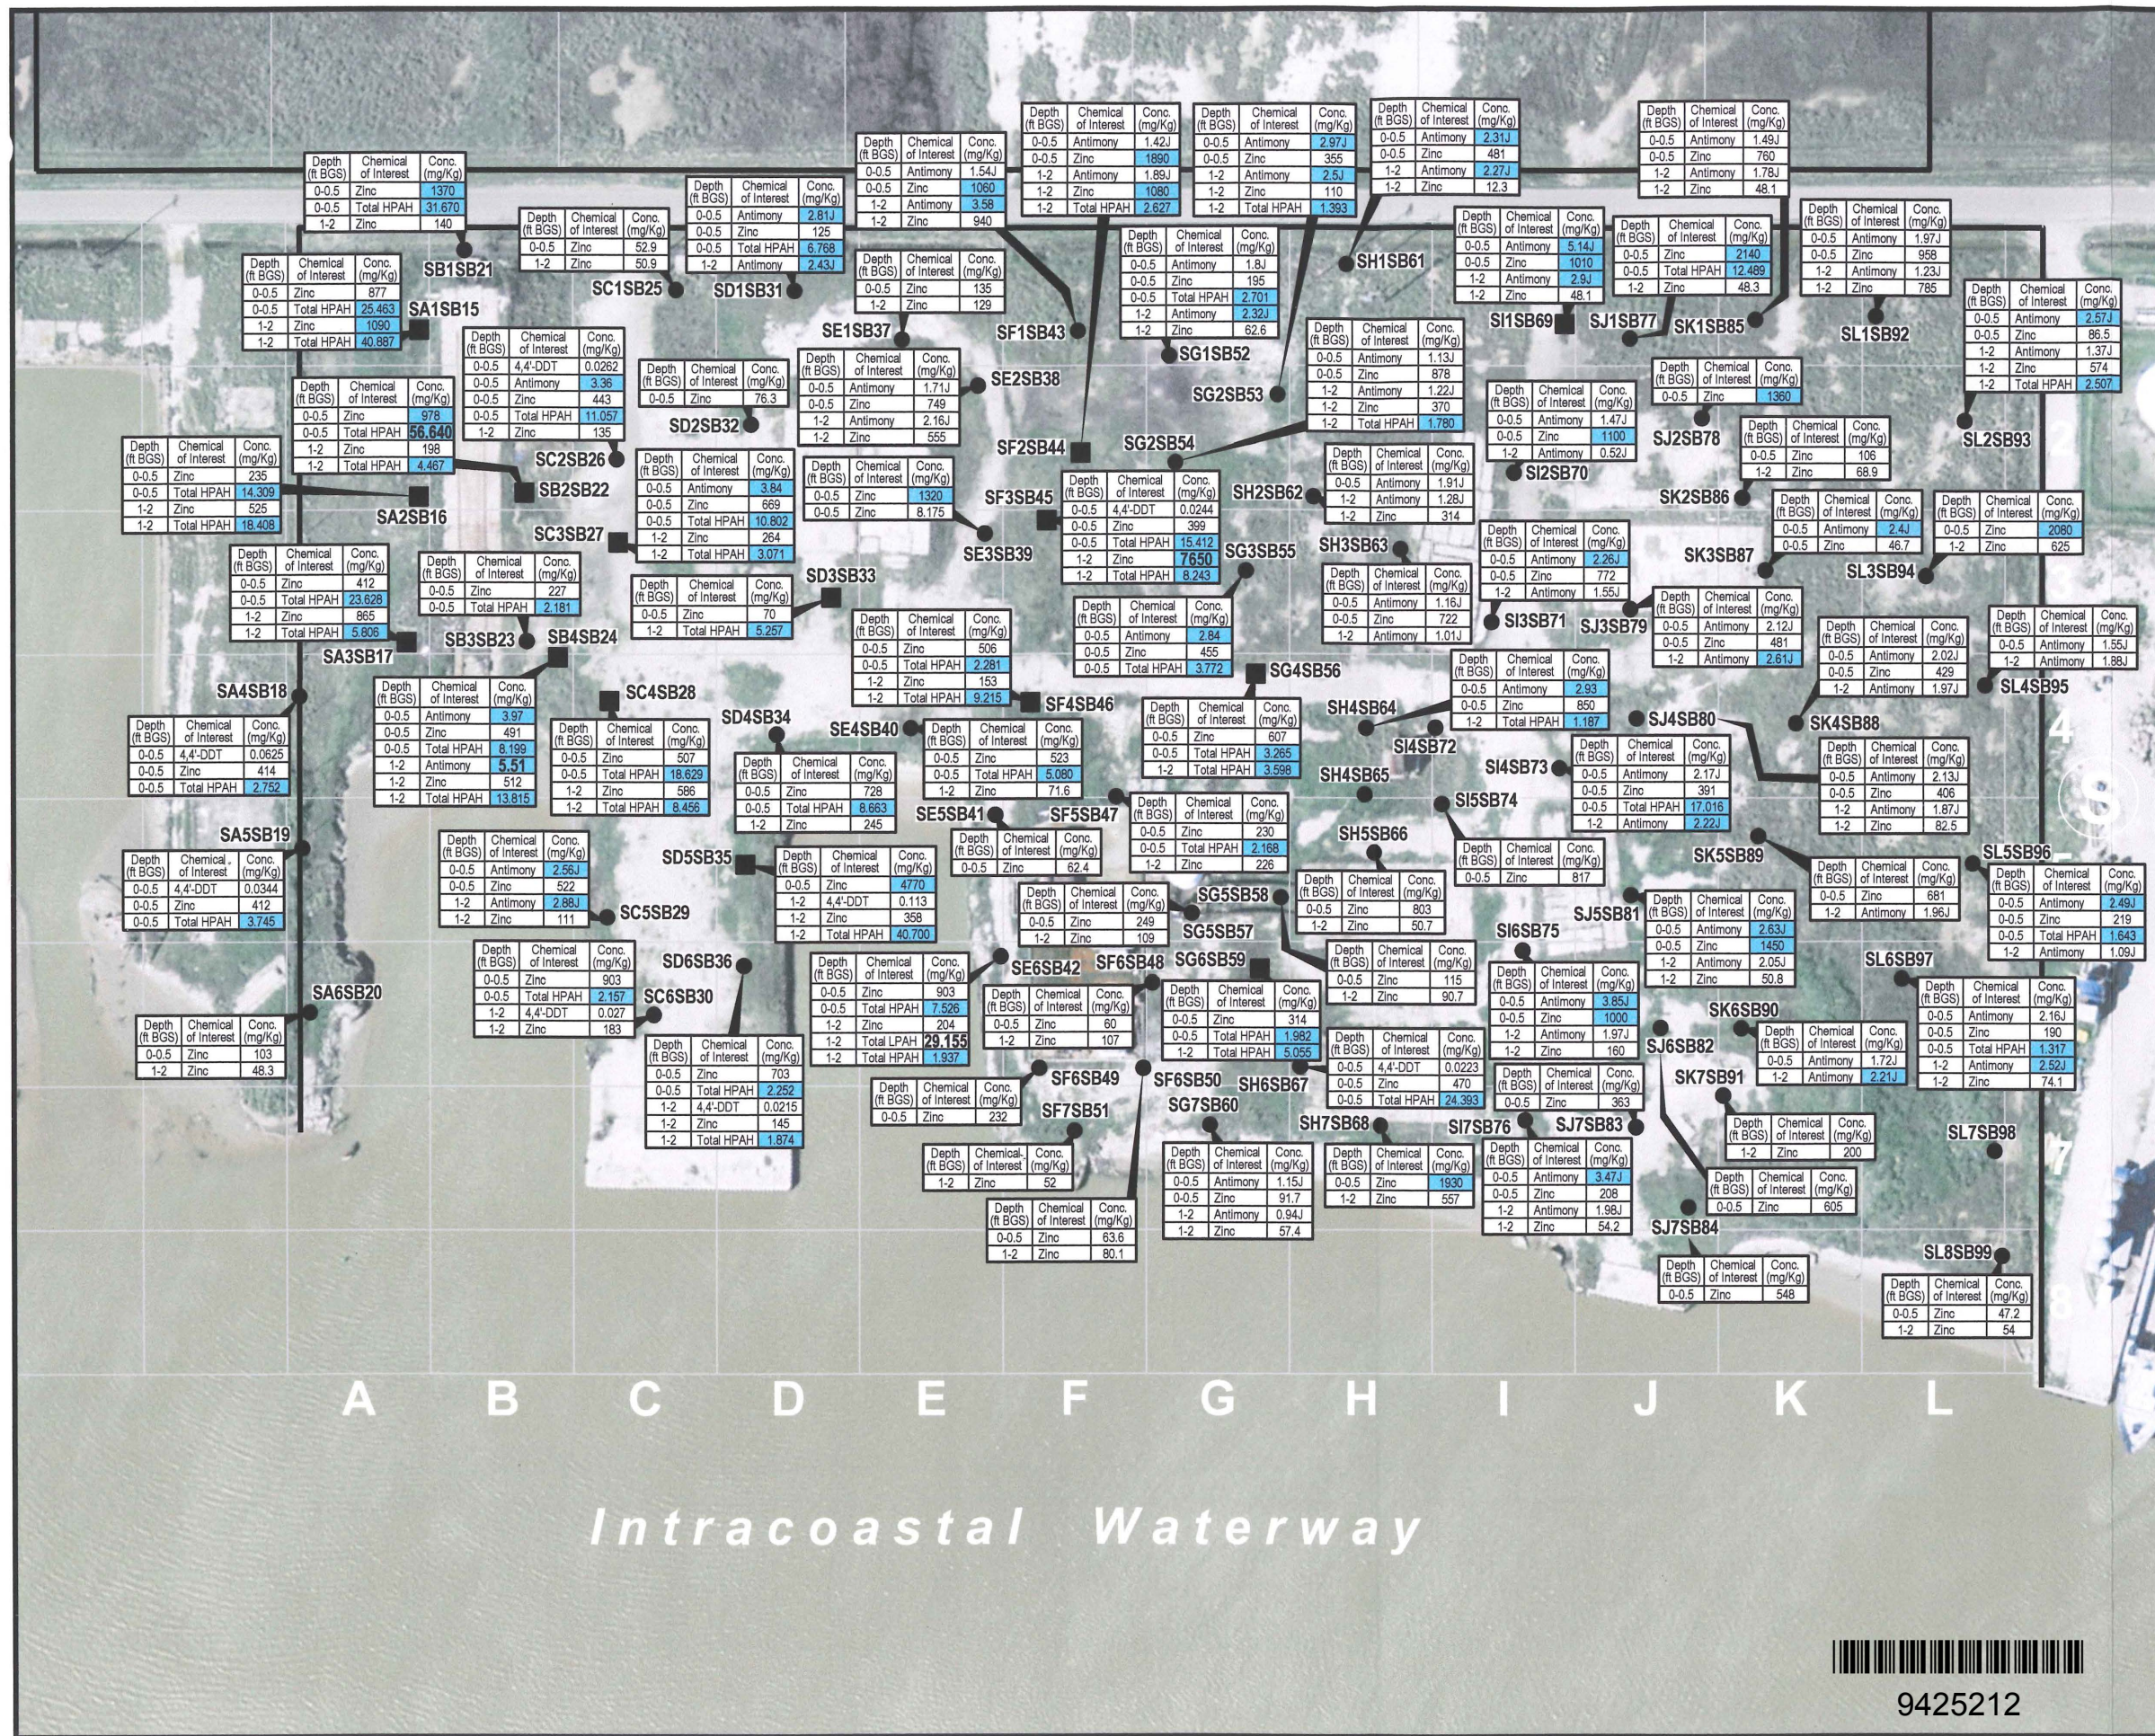
1. Data Qualifier: J = Estimated value.
 2. BGS = below ground surface.
 3. Light blue highlighted values are higher than maximum background concentrations (See Figure 8 for background soil data).
 4. Bold values are the maximum measured concentration for that compound.
- * The compounds shown in the figure are the compounds that were detected at a concentration greater than the screening level (See Tables 1 & 2).
The screening levels are:
Antimony - 0.27 mg/kg
4,4'-DDT - 0.021 mg/kg
Zinc - 46 mg/kg
Total LPAH - 29 mg/kg
Total HPAH - 1.1 mg/kg

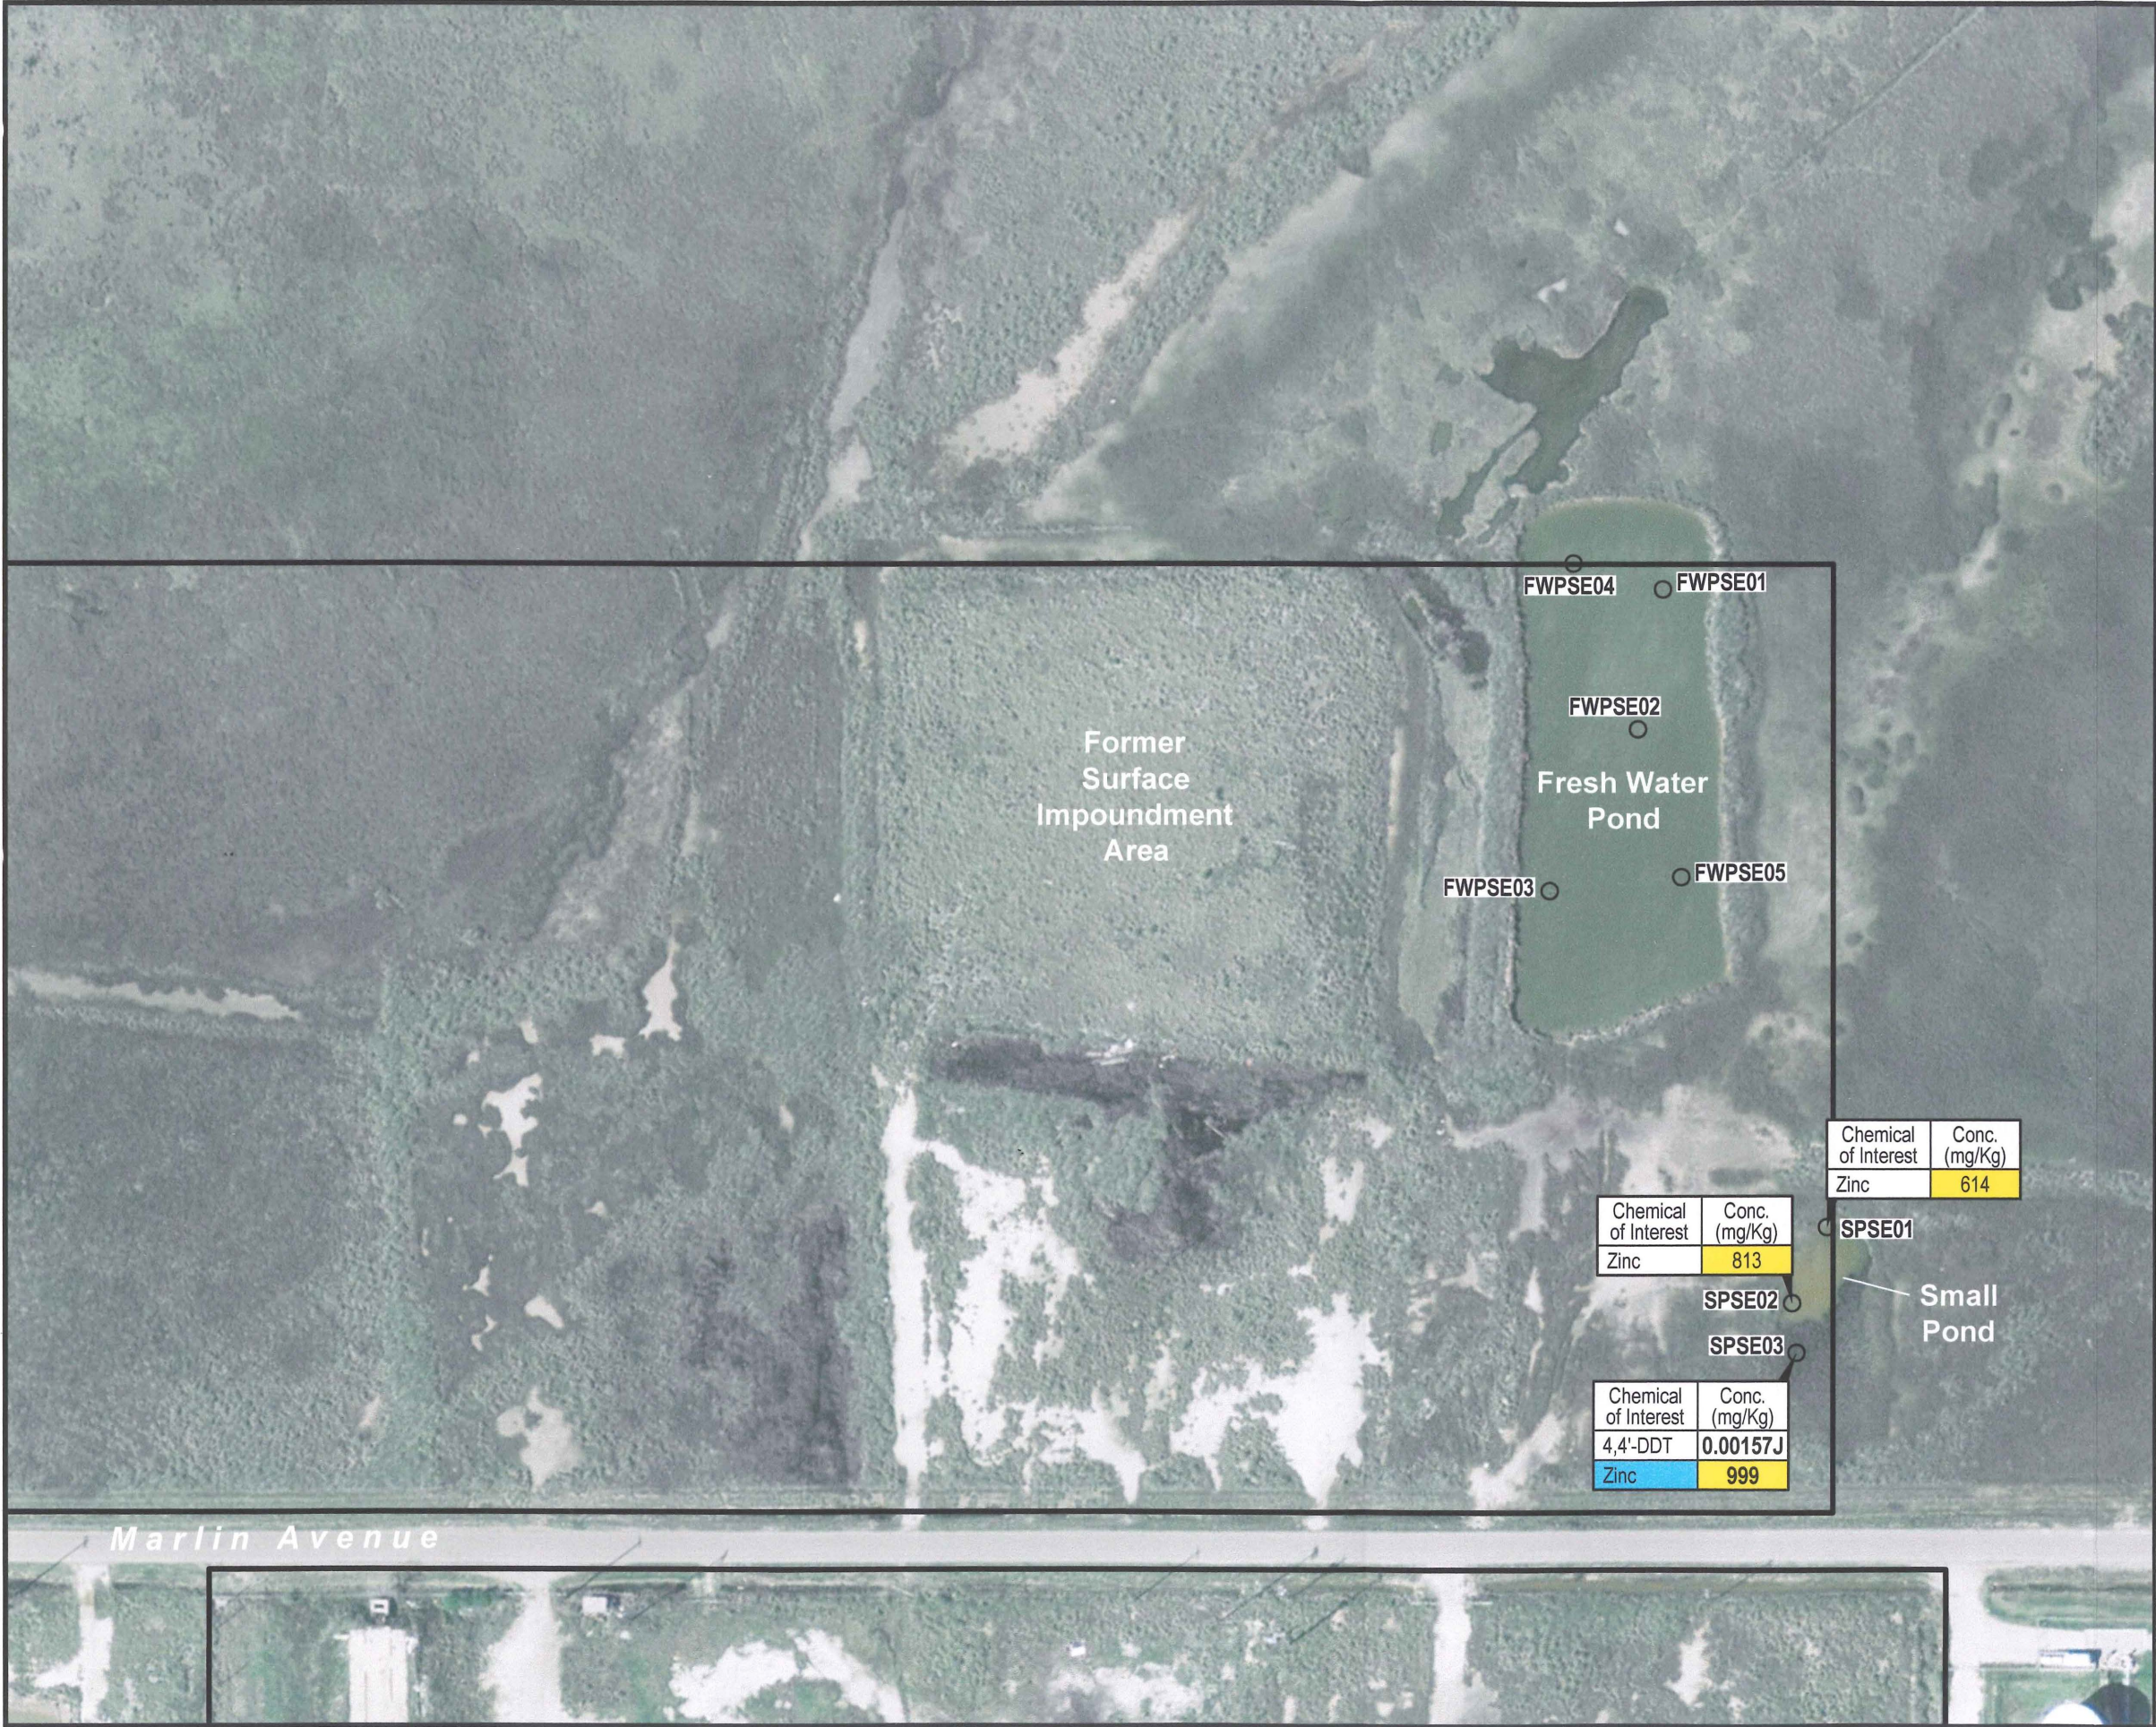
Figure 12
**DETECTED CONCENTRATIONS
EXCEEDING ECOLOGICAL SCREENING
LEVELS FOR BENTHIC INVERTEBRATES*
- PONDS SEDIMENT**

1. All samples from 0-0.5 ft depth interval.
2. Data Qualifiers: J = Estimated value.
3. Bolded values are the maximum measured concentration for that compound.
4. Light blue highlighted values are higher than maximum background concentrations (See Figure 8 for soil background data).

* Values shown in the figure exceed the Effects Range Low (ERL) (See Table 9). Yellow highlighted values exceed the midpoint of the ERL and Effects Range Medium (ERM). The ERLs are:
4,4'-DDT - 0.0012 mg/kg
Zinc - 150 mg/kg

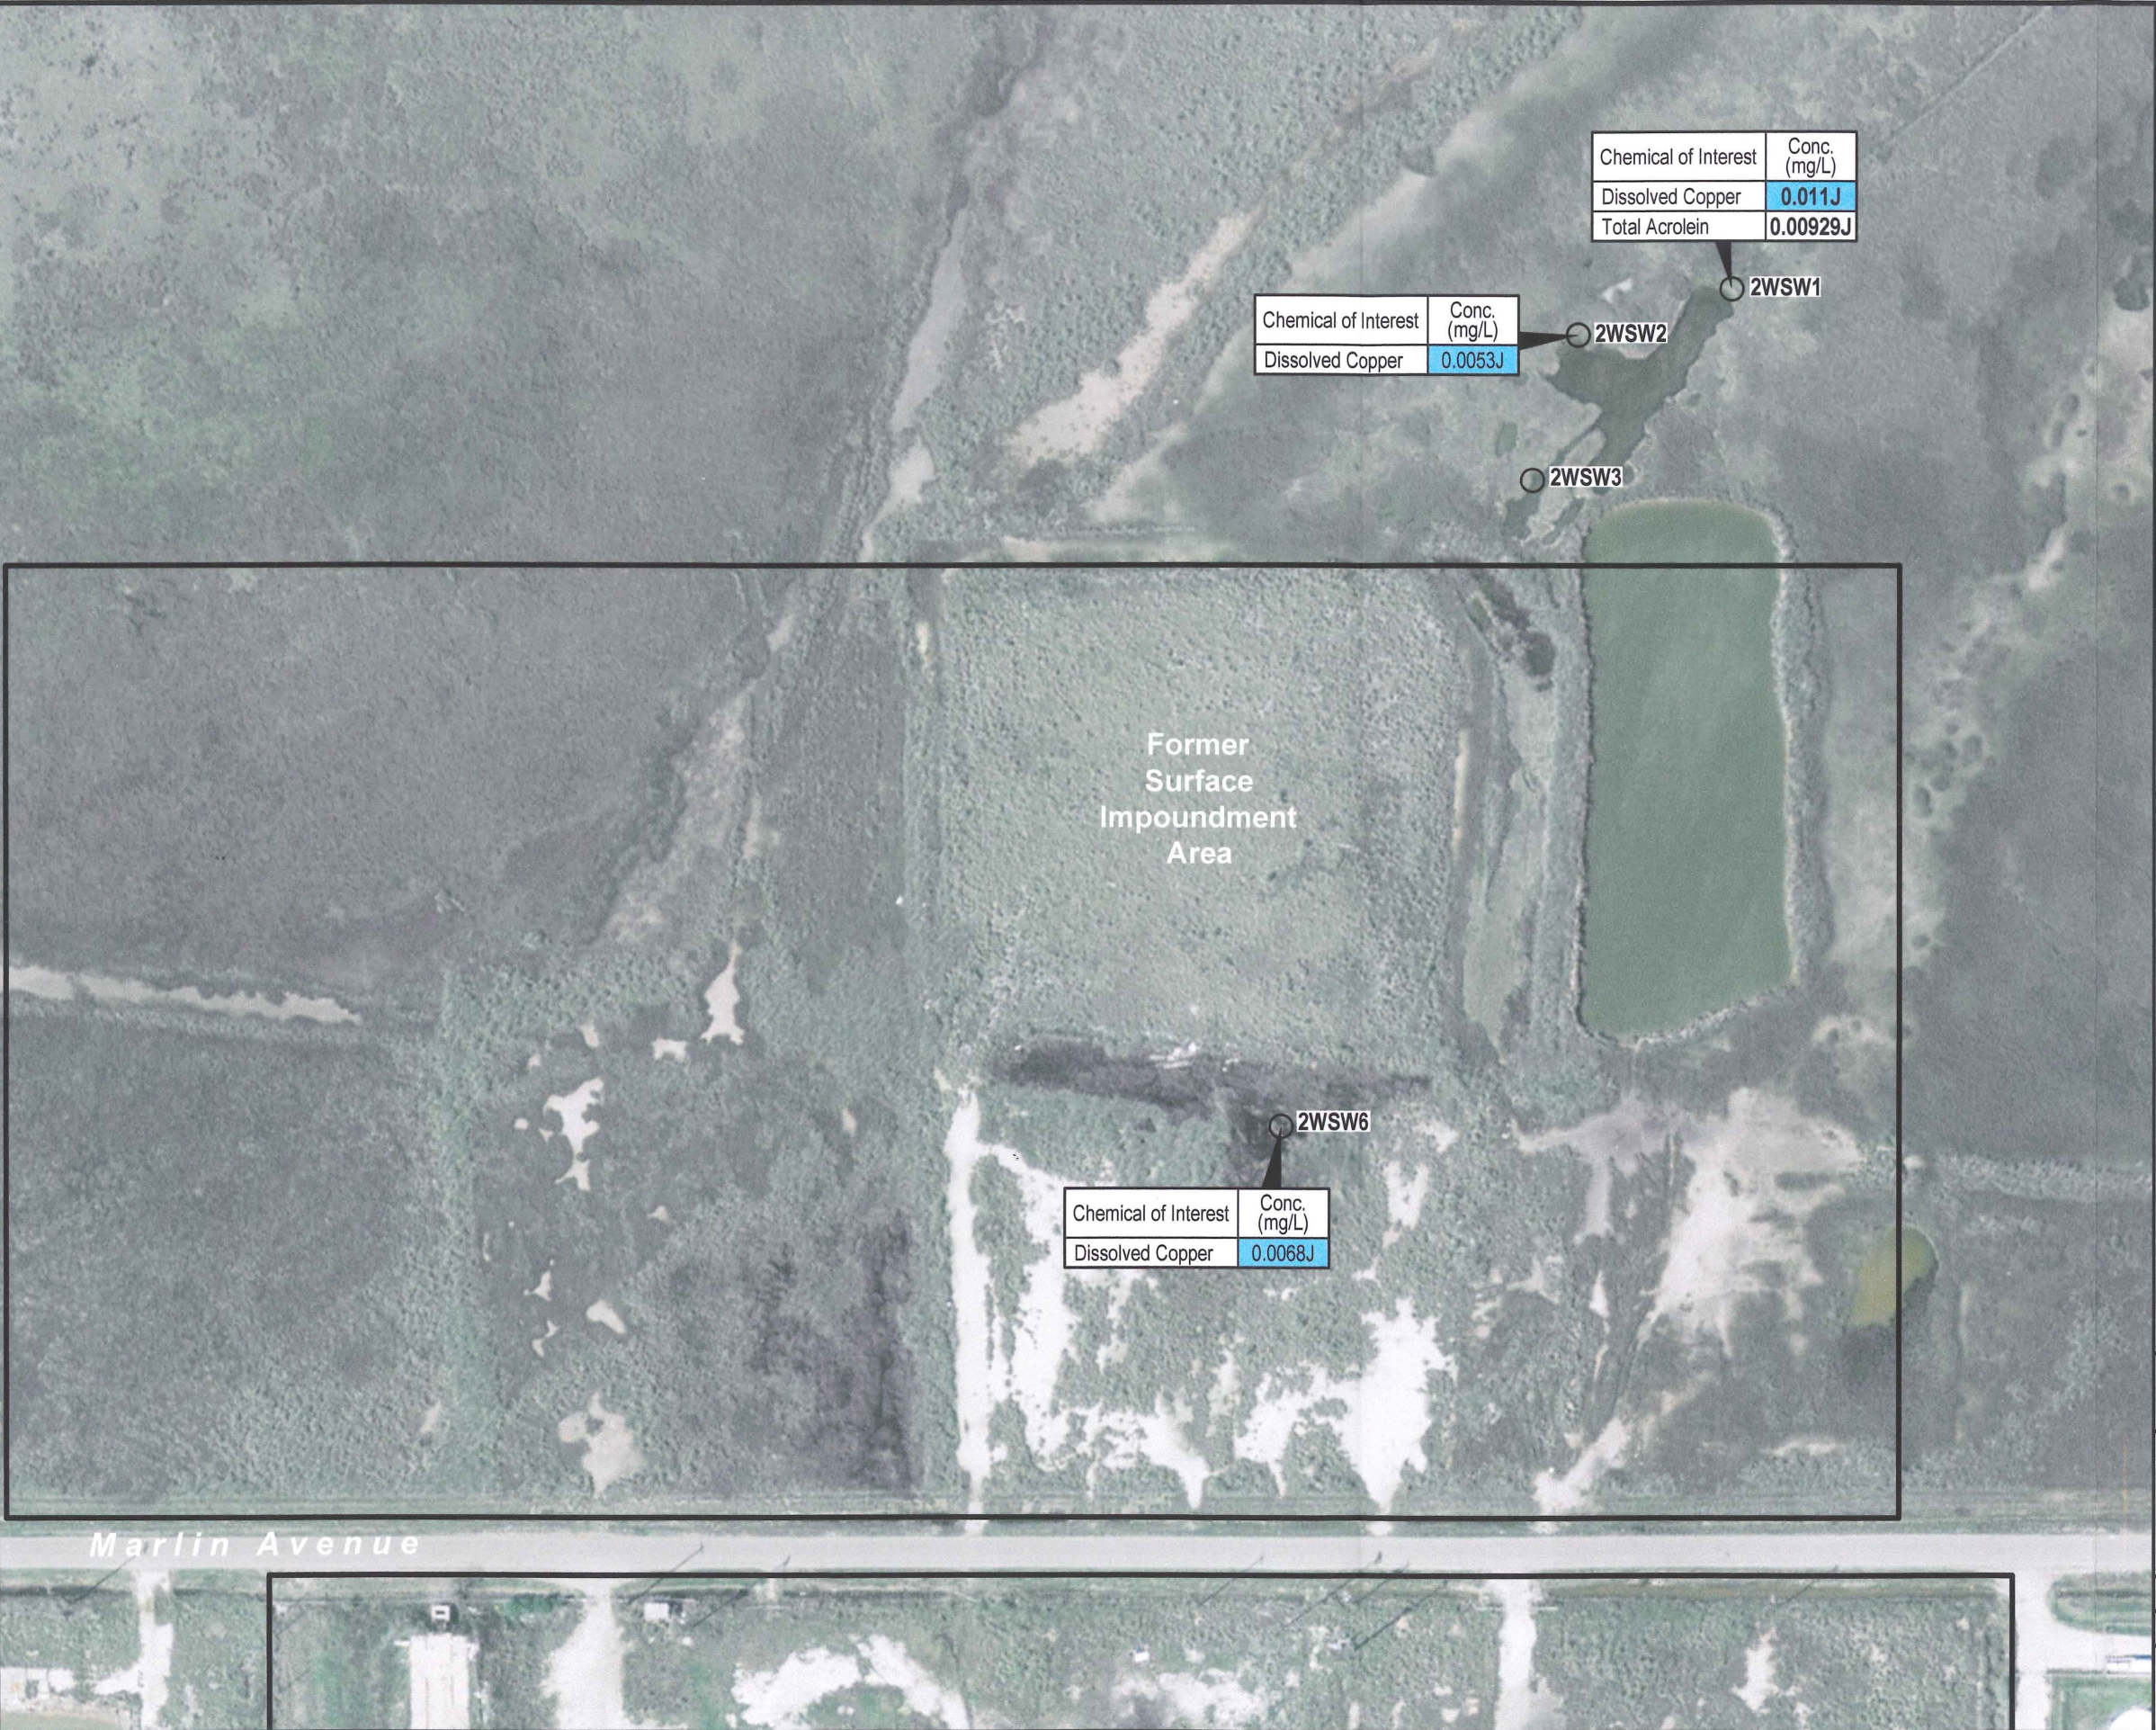
Figure 14
**DETECTED CONCENTRATIONS
EXCEEDING ECOLOGICAL SCREENING
LEVELS FOR AQUATIC RECEPTORS*
- WETLAND SURFACE WATER**

Chemical of Interest	Conc. (mg/L)
Dissolved Copper	0.011J
Total Acrolein	0.00929J

- Notes:**
- 1. Data Qualifier: J = Estimated value.
 - 2. Light blue highlighted values exceed concentrations measured in background surface water (See Figure 13 for background surface water concentrations).
 - 3. Bolded values are the maximum measured concentration for that compound.
 - * Values shown in the figure exceed the TCEQ Ecological Benchmark for Water (See Tables 12 & 16).

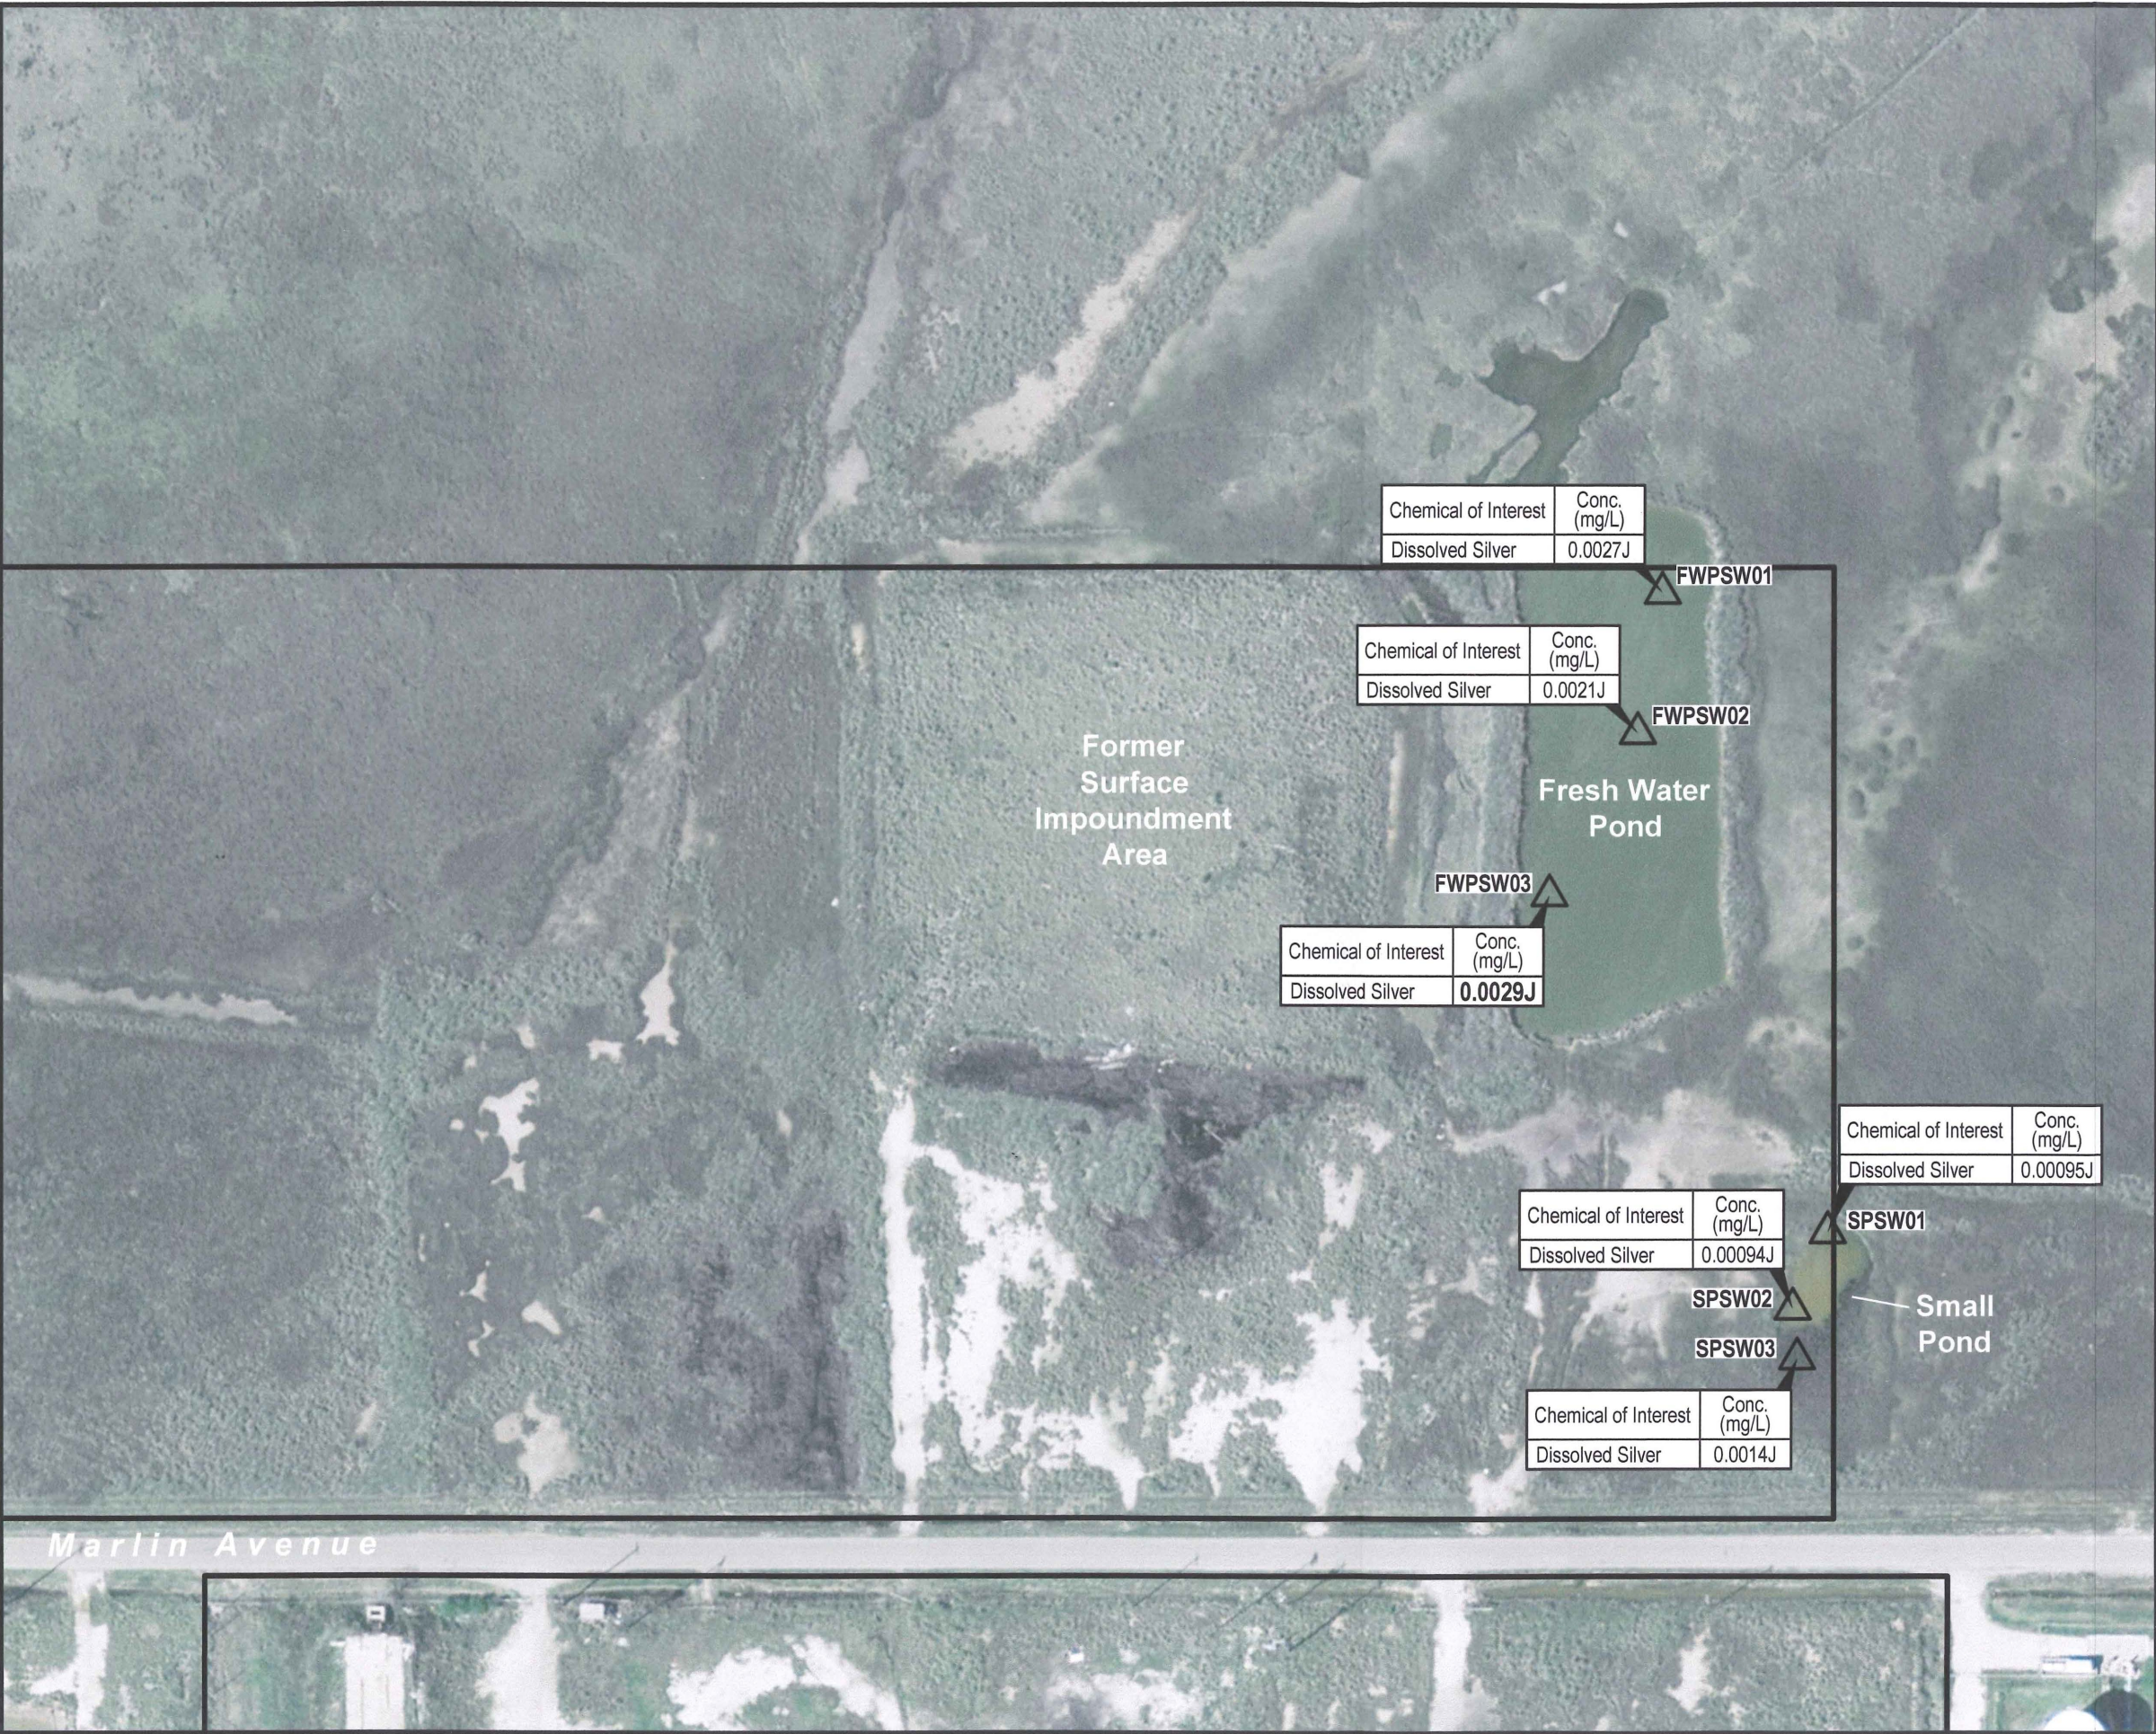
Figure 15
**DETECTED CONCENTRATIONS
EXCEEDING ECOLOGICAL SCREENING
LEVELS FOR AQUATIC RECEPTORS*
- PONDS SURFACE WATER**

- Notes:
- 1. Data Qualifier: J = Estimated value.
 - 2. Bolded values are the maximum measured concentration for that compound.
 - 3. No compounds were measured above background concentrations (See Figure 13 for background surface water concentrations).
 - * Values shown in the figure exceed the TCEQ Ecological Benchmark for Water (See Tables 13 & 17).
